**THE STREAMBANK EROSION CONTROL
EVALUATION AND DEMONSTRATION ACT OF 1974
SECTION 32, PUBLIC LAW 93-251**

Appendix E - Missouri River Demonstration Projects

Volume 2 of 2

4. TITLE (and Subtitle) LITERATURE SURVEY AND PRELIMINARY EVALUATION OF STREAMBANK PROTECTION METHODS		5. TYPE OF REPORT & PERIOD COVERED Final report
		6. PERFORMING ORG. REPORT NUMBER

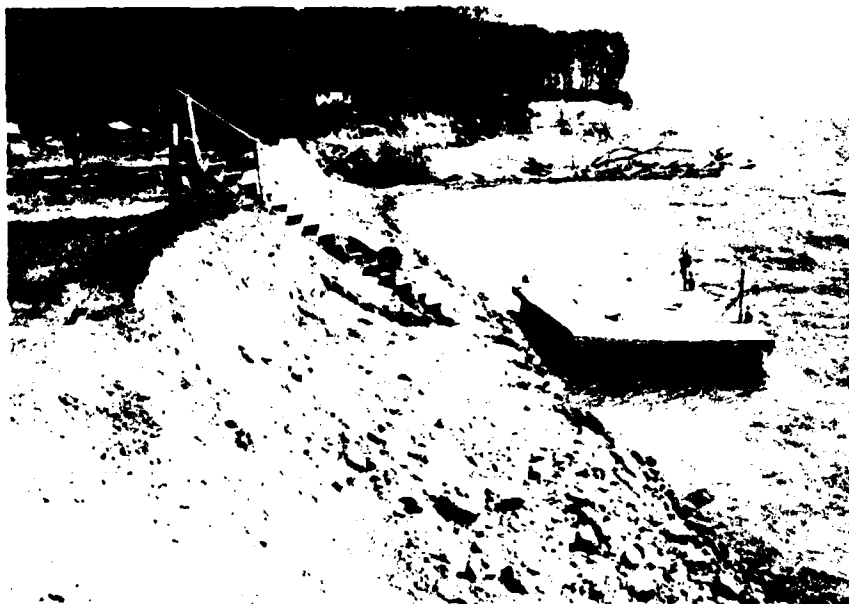
**PHOTO 28. COMPOSITE REVETMENT 782.7* STATION 0+00 AFTER
COMPLETION, LOOKING D/S
(Photo Taken 13 August 1978)**

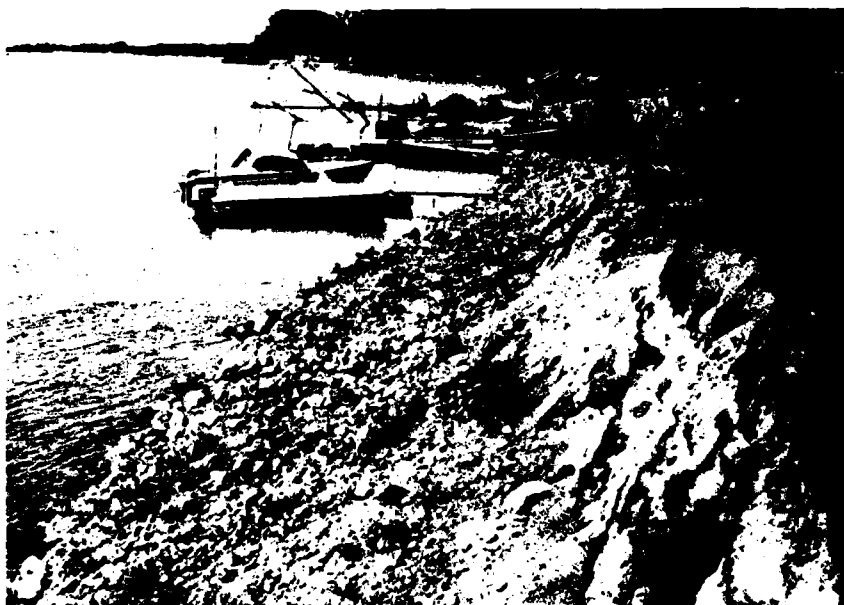
PHOTO 30. COMPOSITE REVETMENT 782.7* STATION 9+00
AFTER COMPLETION, LOOKING U/S
(Photo Taken 16 August 1978)

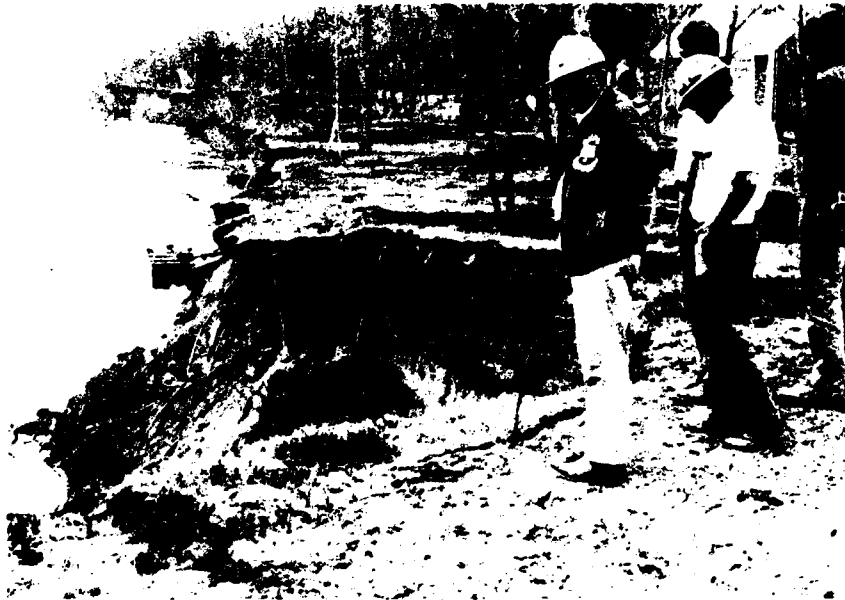
PHOTO 33. TYPICAL SEVERE EROSION CONDITIONS AT RIVER MILE 783.2*
 (Photo Taken 12 April 1977)

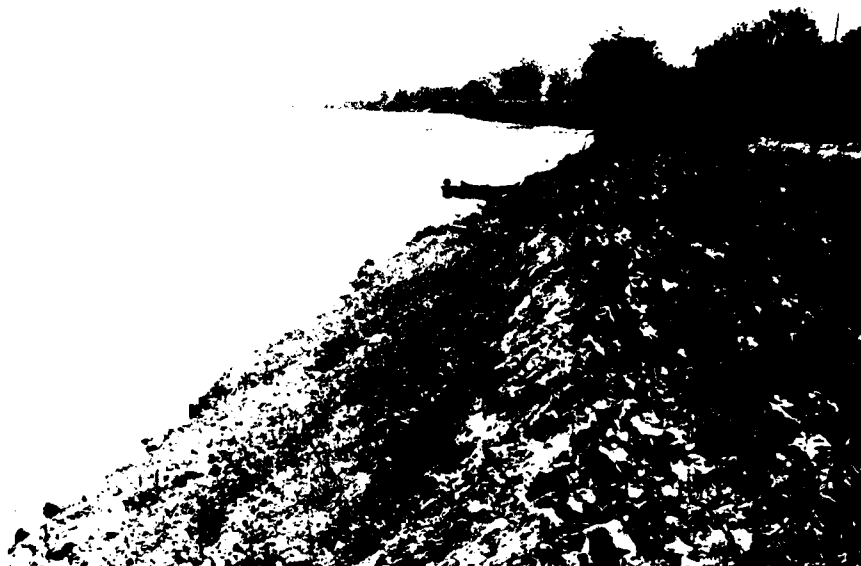
**PHOTO 45. COMPOSITE REVETMENT 775.9* STATION 16+00, LOOKING D/S.
TOE FILL OF LOW GRADE MATERIAL COVERED WITH A THIN GRAVEL BLANKET
(Photo Taken 6 August 1978)**

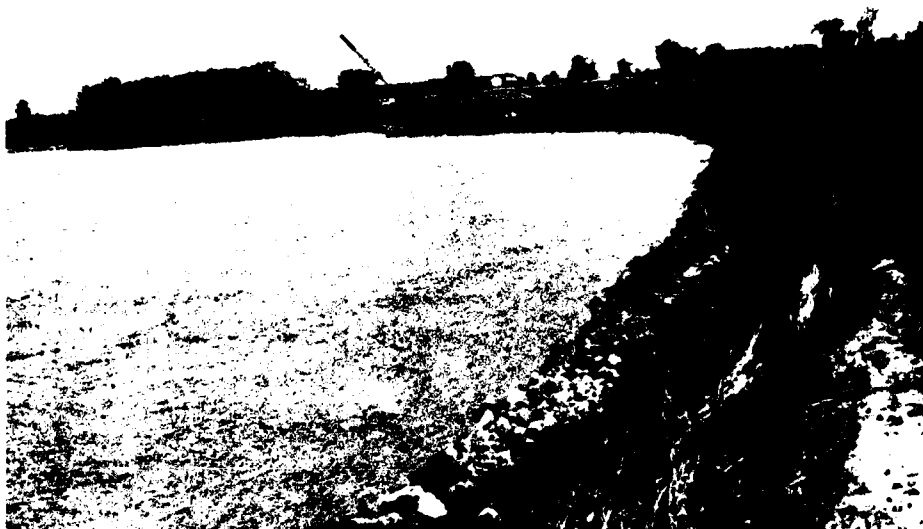
PHOTO 47. COMPOSITE REVETMENT 774.9* DURING CONSTRUCTION.
TOE CONSTRUCTED ENTIRELY OF LOW GRADE MATERIAL
AND COVERED WITH A THIN LAYER OF GRAVEL
(Photo Taken 14 May 1980)

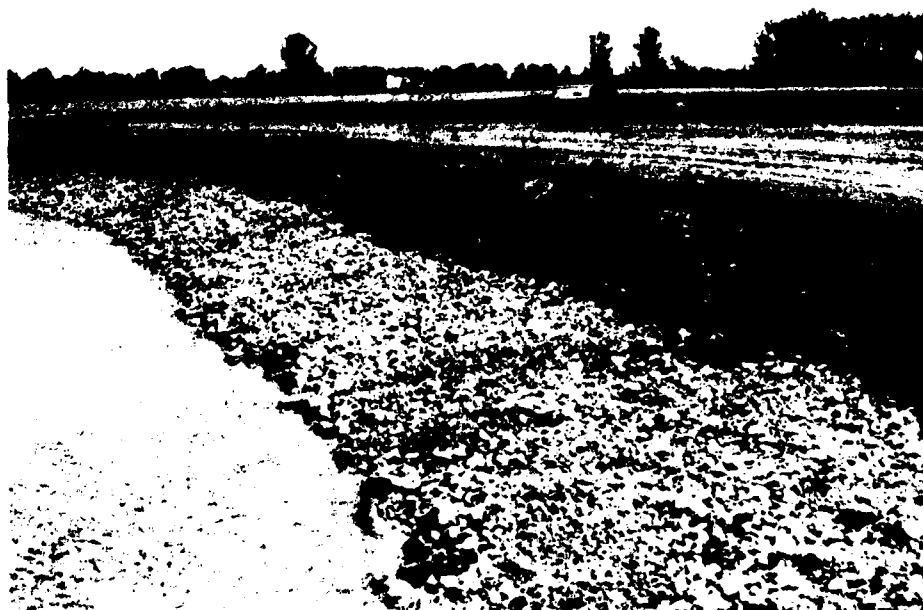
PHOTO 48. COMPOSITE REVETMENT 774.9*, IMMEDIATELY AFTER
STRUCTURE COMPLETION
(Photo Taken 12 May 1980)

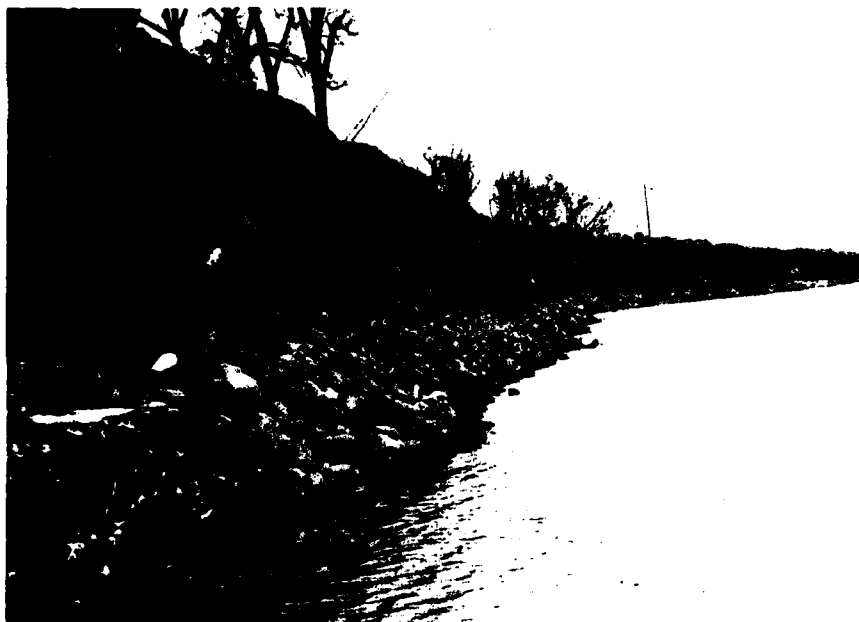
**PHOTO 55. WINDROW REVETMENT 771.9*, STATION 25+00 APPROXIMATELY
7 MONTHS AFTER COMPLETION
(Photo Taken 2 December 1977)**

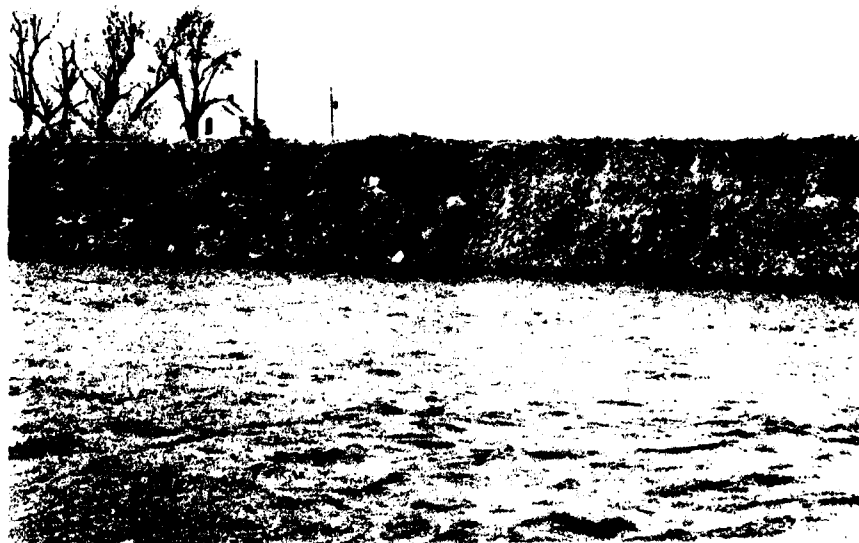
**PHOTO 56. WINDROW REVETMENT 771.9*, APPROXIMATELY 1 YEAR AND
11 MONTHS AFTER COMPLETION
(Photo Taken 17 April 1979)**

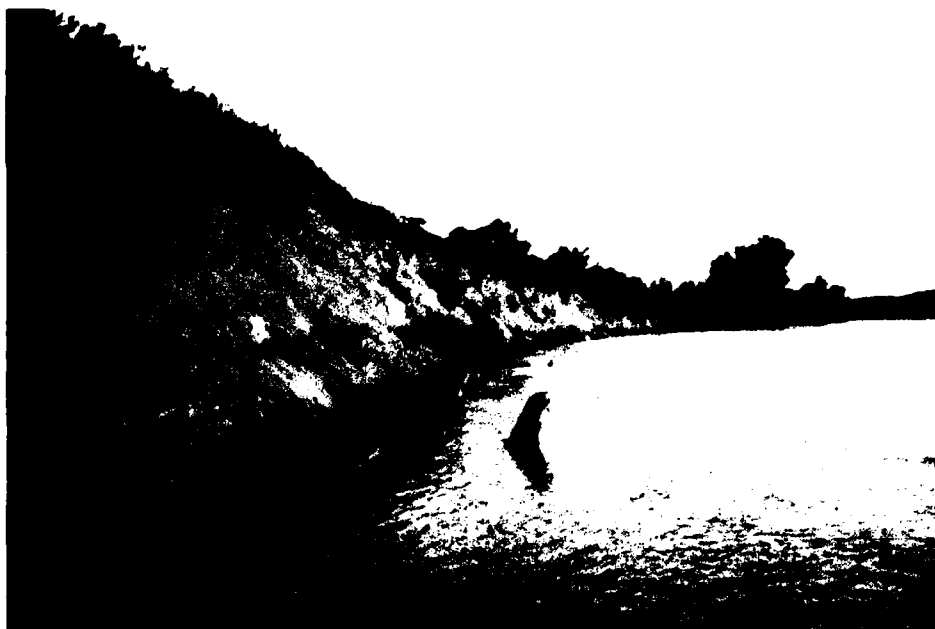
**PHOTO 75. SITE OF COMPOSITE REVETMENT 754.77*
PRIOR TO CONSTRUCTION, LOOKING D/S
(Photo Taken 15 September 1979)**

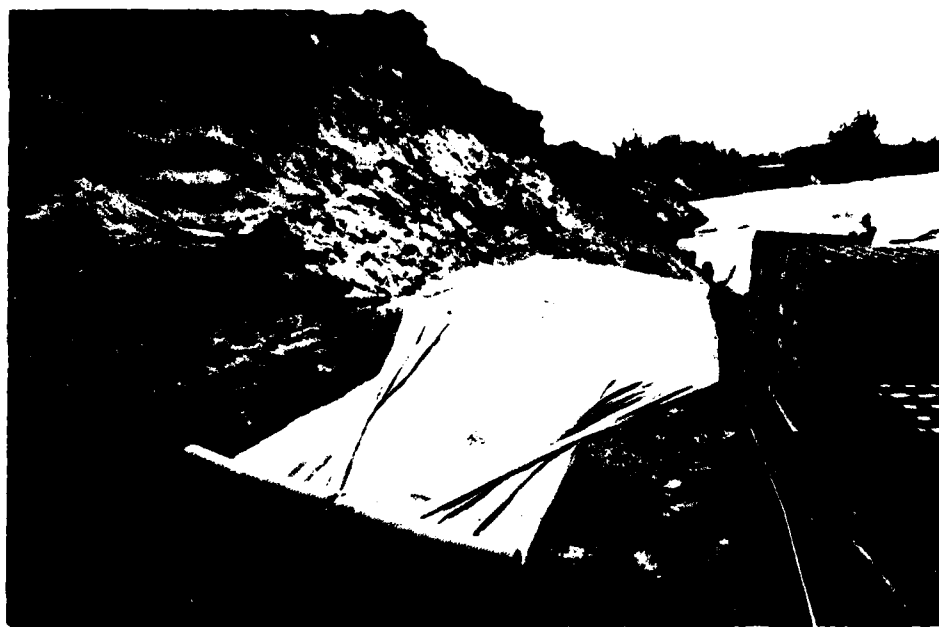
**PHOTO 76. COMPOSITE REVETMENT 754.77* DURING PLACEMENT OF HOLD/GRO
FABRIC, AND PRIOR TO PLACEMENT OF CELLULAR CONCRETE BLOCKS, LOOKING D/S
(Photo Taken 19 March 1980)**

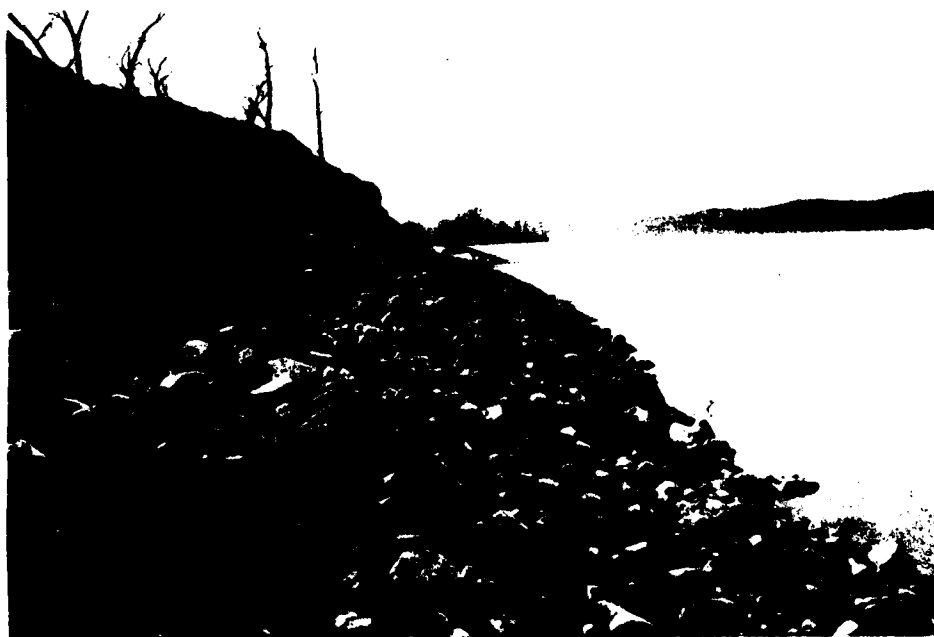
**PHOTO 78. COMPLETED COMPOSITE REVETMENT 754.77* IMMEDIATELY AFTER
GRAVEL PLACEMENT OVER THE CELLULAR CONCRETE BLOCKS
(Photo Taken 3 April 1980)**

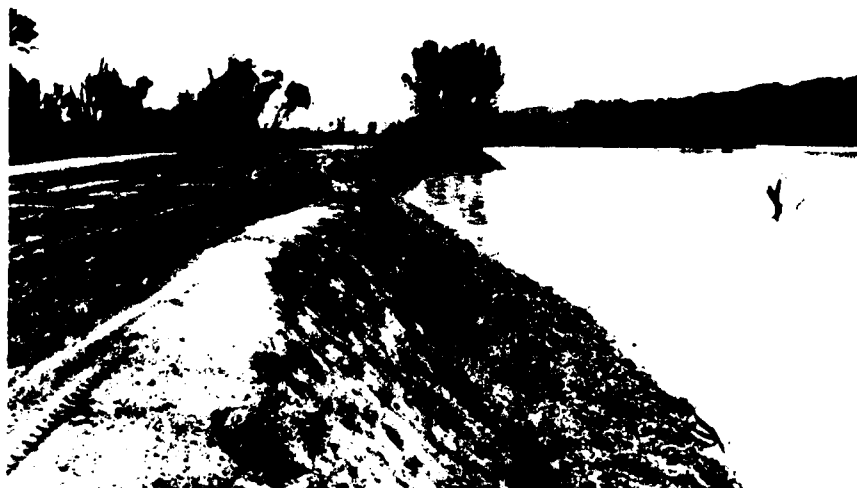
**PHOTO 82. COMPOSITE REVETMENT 753.66*, TYPE E, STATION 8+00
THREE WEEKS AFTER COMPLETION, LOOKING D/S
(Photo Taken 8 August 1980)**

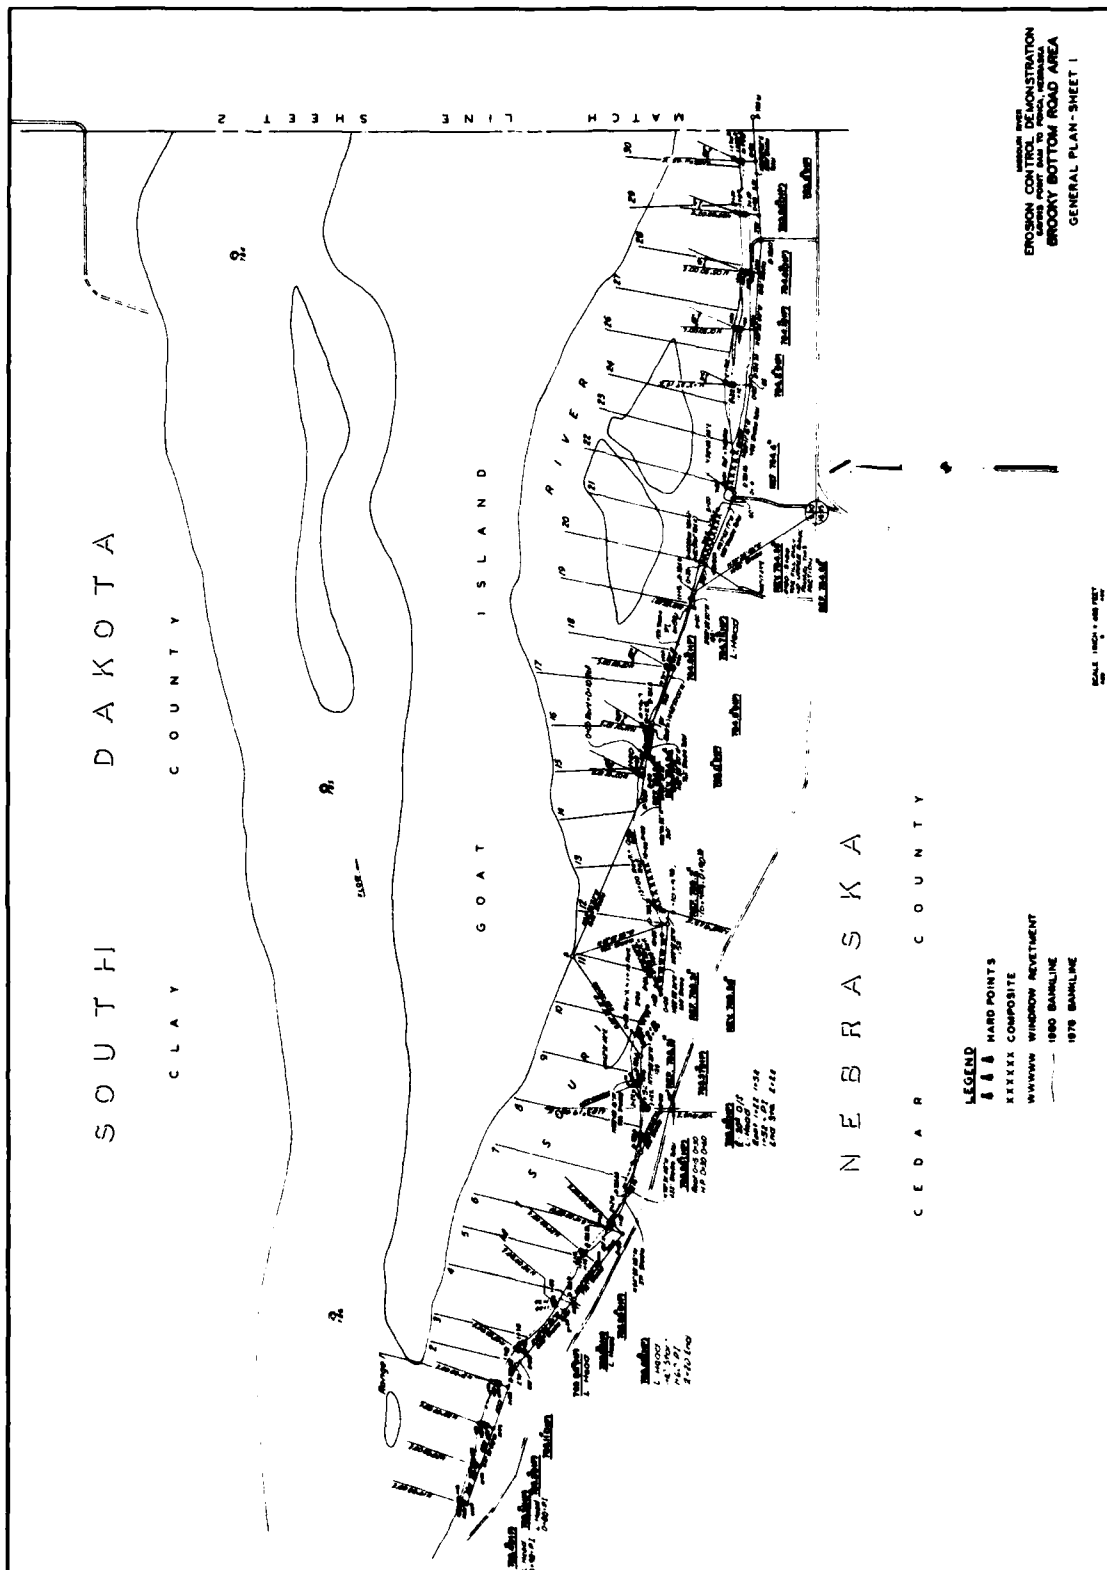
PLATE 5-1

5. BROOKY BOTTOM ROAD PROJECT AREA. The general plan for this project is shown on plates 5-1 and 5-2. The initial construction consisted of 6 segments of composite revetment totalling 2,395 linear feet, 2 segments of windrow revetment totalling 800 linear feet, 8 windrow refusals totalling 771 linear feet, and three hardpoint systems consisting of 3, 4, and 6 hardpoints respectively. The construction of additional structures was necessitated due to severe erosion conditions at unprotected areas at the demonstration site. Modification No. 2 involved an additional 588 linear feet of composite revetment and 224 linear feet of windrow refusal. Modification No. 3 involved an additional 150 linear feet of composite revetment, 10 linear feet of windrow refusal, and 17 hardpoints. The hardpoints were distributed among the existing systems so the system farthest upstream now consists of 11 hardpoints. The center system consists of 5 hardpoints and the system farthest downstream consists of 14 hardpoints. Typical sections of the structure types used in this project are shown on plate 5-3.

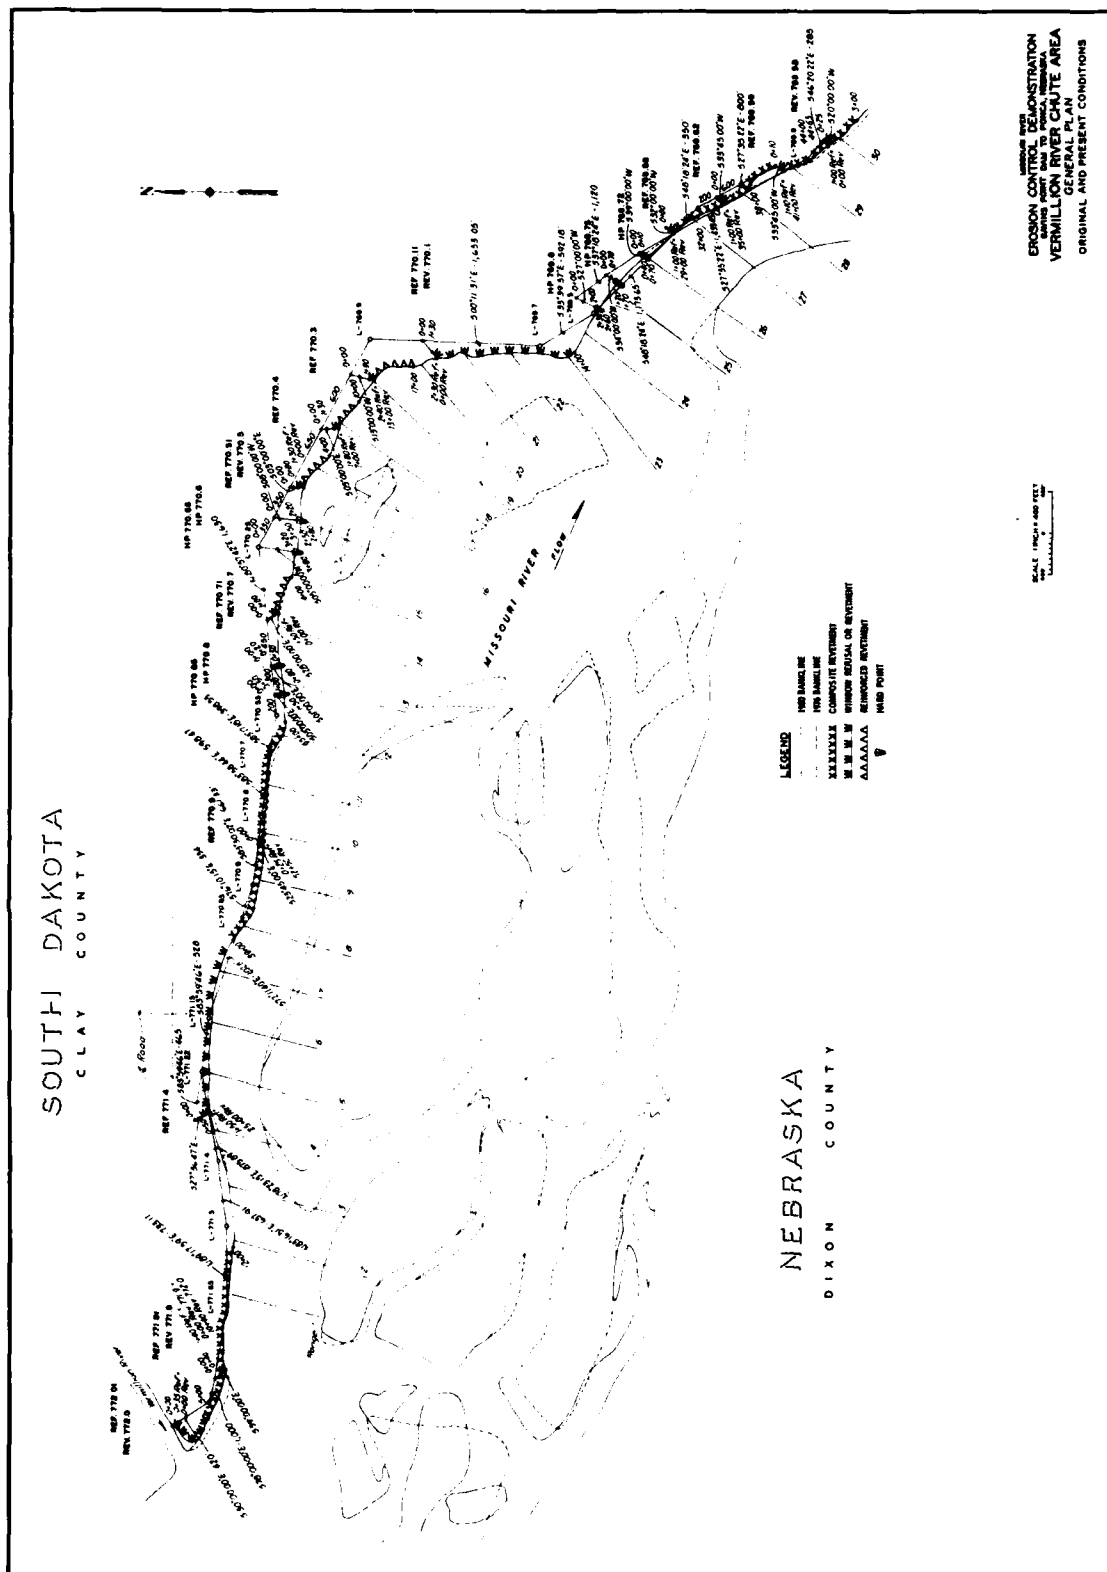
PLATE 8-1

7. VERMILLION RIVER CHUTE PROJECT AREA. The general plan for this project is shown on plate 8-1. Initial construction consisted of 4 segments of windrow revetment totalling 3,328 linear feet, 7 windrow refusals totalling 489 linear feet, and one system of 3 hardpoints. Additional structures were constructed by modifications to existing construction contracts.

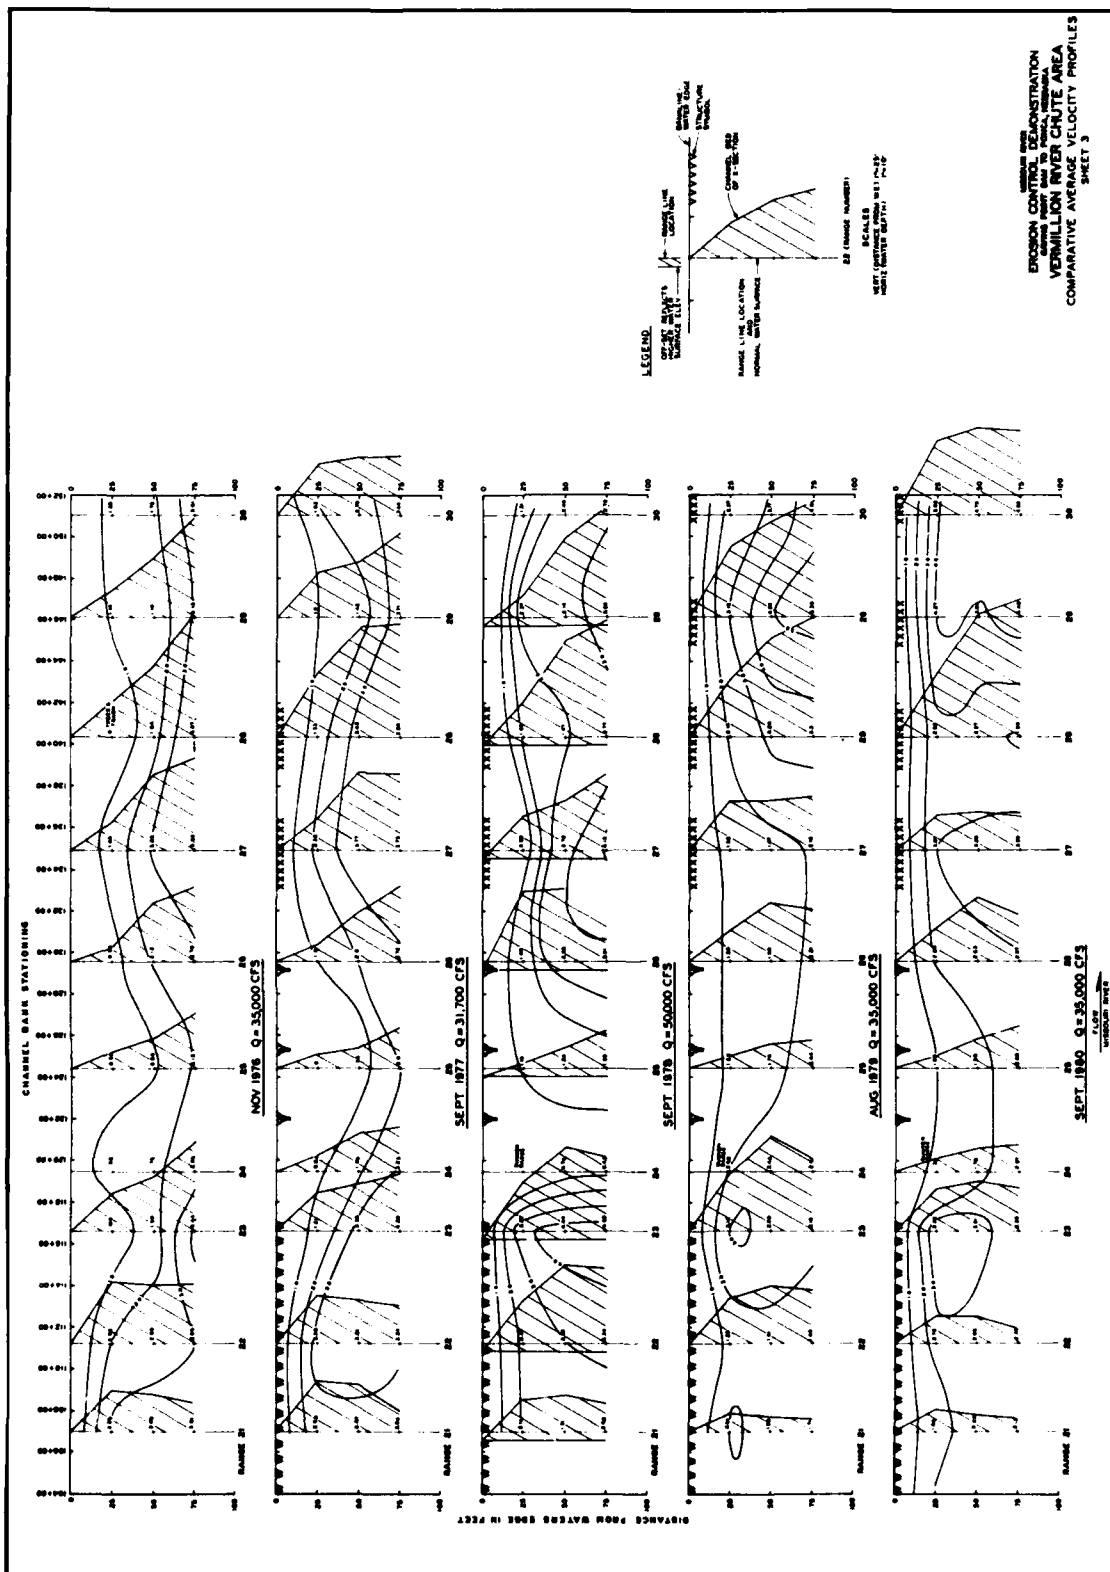
PLATE 8-13

(3) Range 21 through 30. The portion of the Vermillion River Chute Area has been under attack by the main flows of the Missouri River since initial construction completion in 1976. Velocities in this area range from 1.4 to 5.5 feet per second. As is shown on Plate 8-13, most of this area has had a scour trend rather than any trend for

bar buildup. As shown on Plate 8-13, the rear bank water depths have maintained very deep conditions, with average near bank channel depths of 10 to 15 feet, with maximum depths of 25-30 frequently encountered.

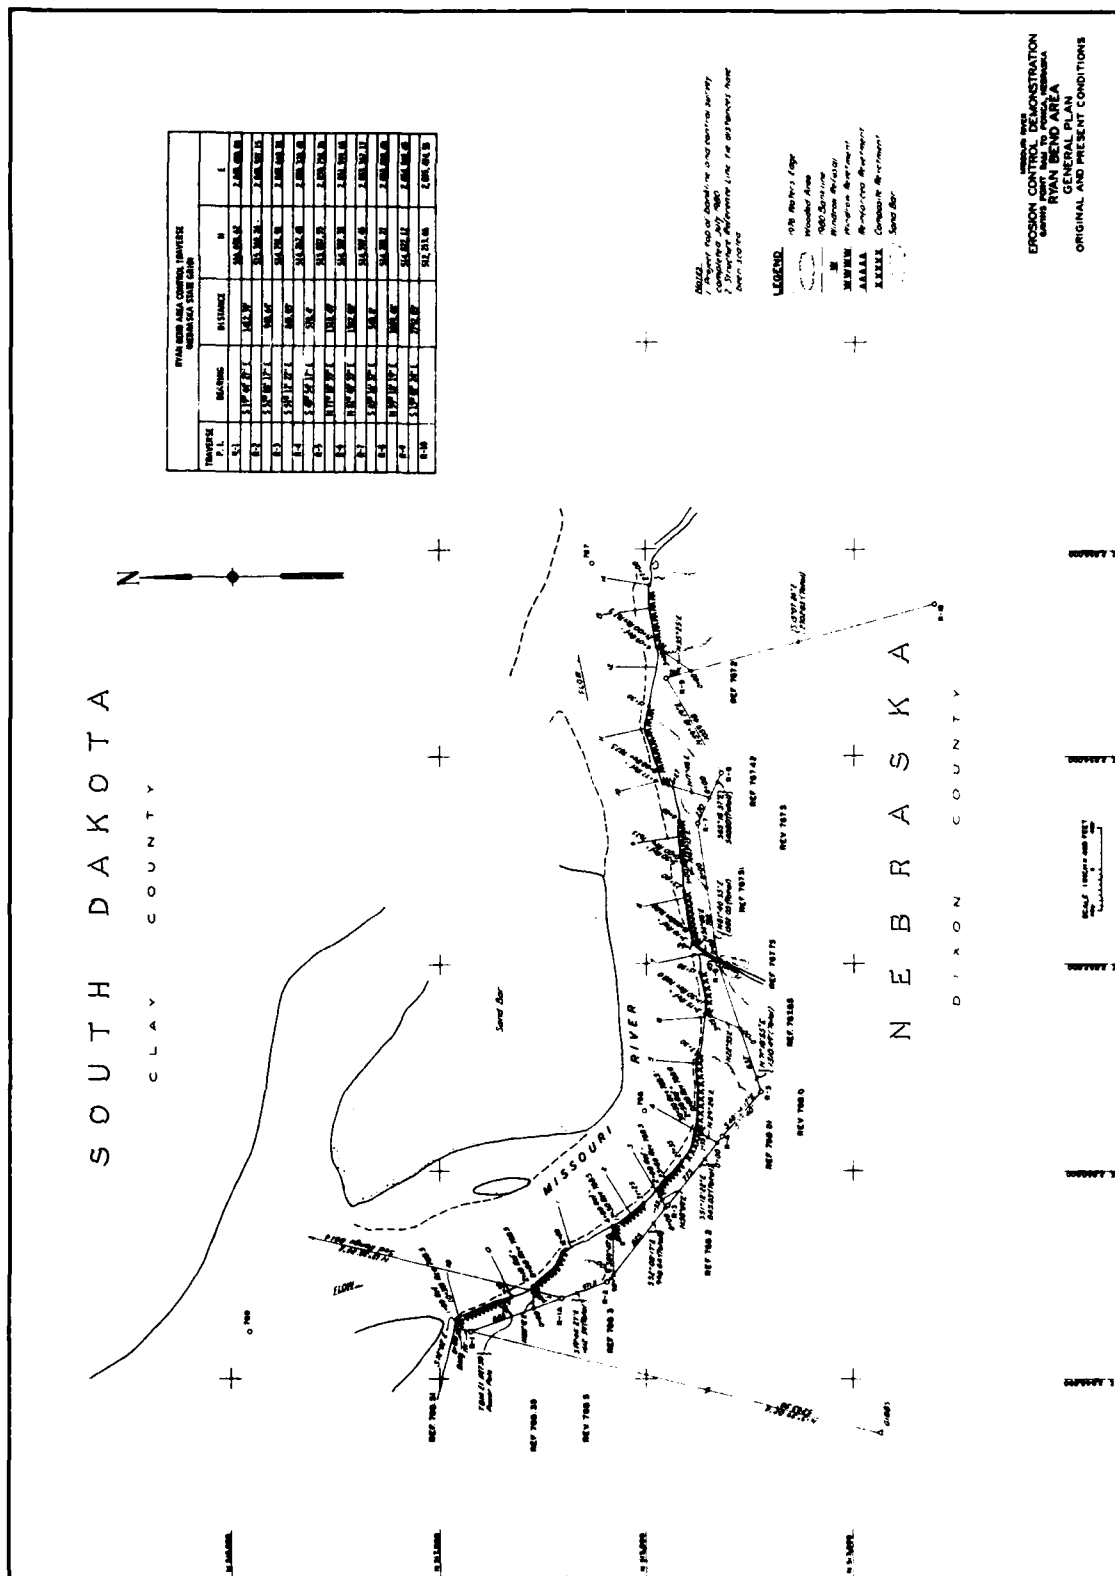
PLATE 9-1

8. **RYAN BEND PROJECT AREA.** The general plan for this project is shown on plate 9-1. The initial construction consisted of 3 segments of windrow revetment totalling 1,500 linear feet, 10 windrow refusals totalling 644 linear feet, 4 segments of reinforced revetment totalling 1,880 linear feet, and 3 segments of composite revetment totalling 1,650 linear feet. Extensions to existing structures were added by Modification No. 4. These additions included 315 linear feet of composite revetment and 150 linear feet of windrow revetment. Typical sections of the structure types used in this project are shown on plate 9-2.
